ICOM COMMITTEE FOR CONSERVATION

8th Triennial Meeting
Sydney, Australia
6–11 September, 1987

Preprints Volume II

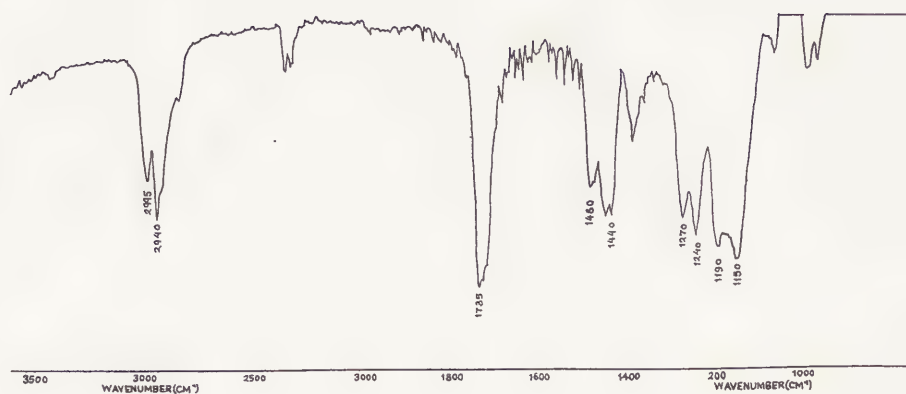
Fig.2 IR spectra of polymethylmethacrylate (polymerised from monomer)

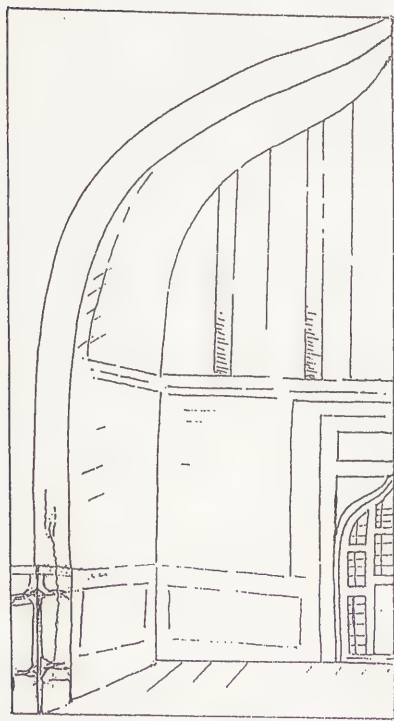
Fig. 2 Sketch of an arch of the central hall showing vertical cracks on the base of the arch

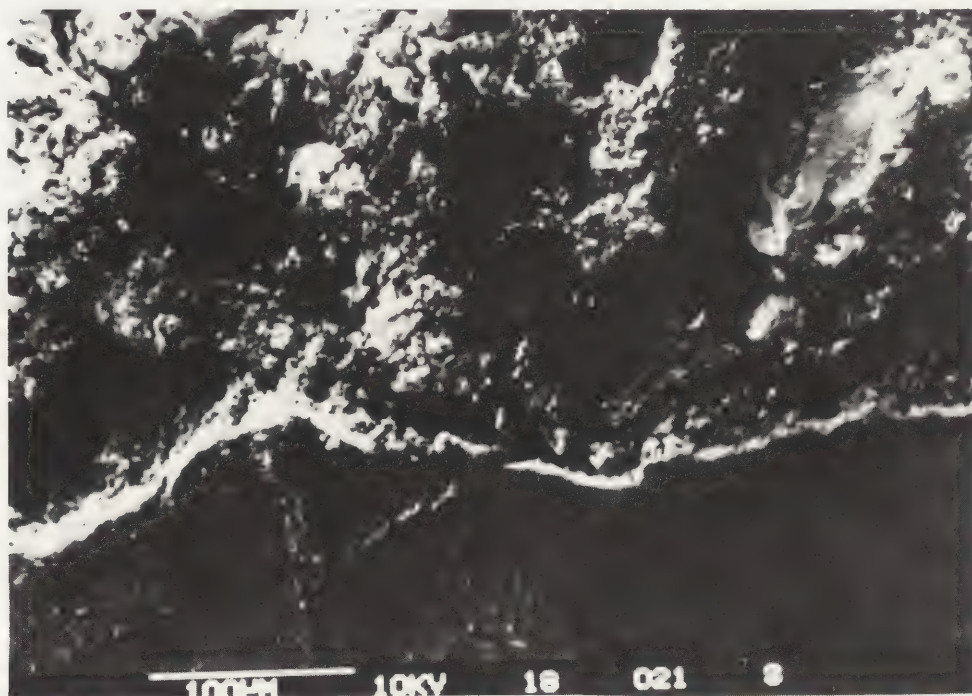
Figure 1. SEM photomicrograph of a cross-section of a plaster sample (TP1) showing the external polishing layer and a view of the internal matrix of the plaster.

SEM studies were carried out on fracture surfaces of the samples. Figure 1 shows a cross-section of a plaster sample (TP1). Figure 2 shows a detail of the interior of another plaster sample (TP2) at higher magnification.

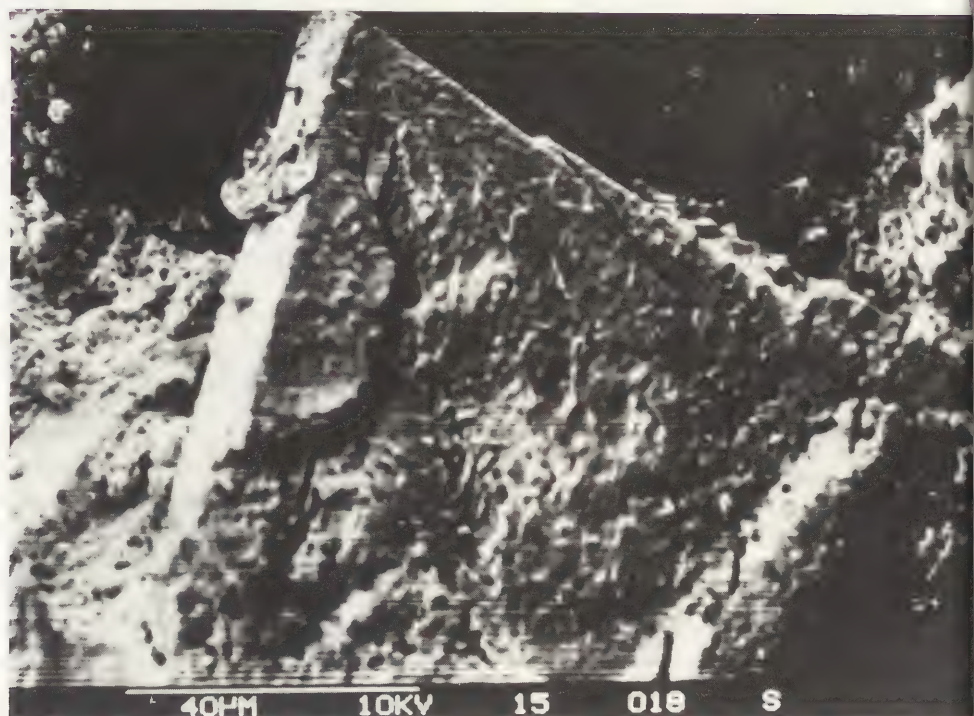
Figure 2. SEM photomicrograph of a fracture surface of the interior matrix of a plaster sample (TP2) showing a calcite crystal pseudomorph. The fissures visible on the pseudomorph originated during the lime-burning process.

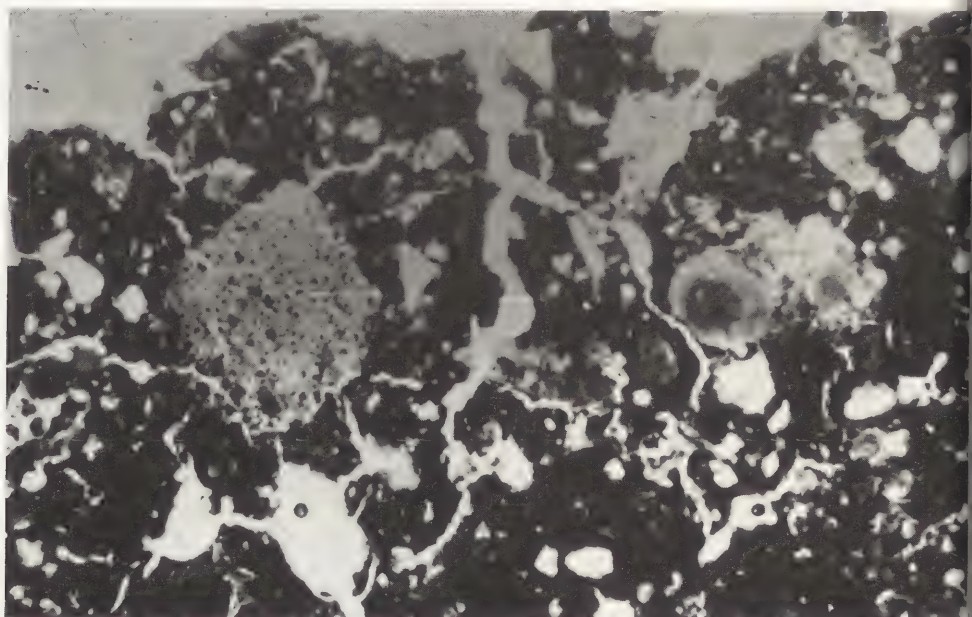
Figure 3. Thin section photomicrograph of the innermost layer of a plaster sample (TP2). Note the pores and microcracks perpendicular to the surface which account for the porosity of the plaster. Also to be observed is a large mass of presumably partially burnt lime. (// Nicol)

Petrography was carried out on thin sections prepared according to NORMAL 12/83 recommendations (13). Figure 3 shows the interior matrix of a plaster sample (TP2).

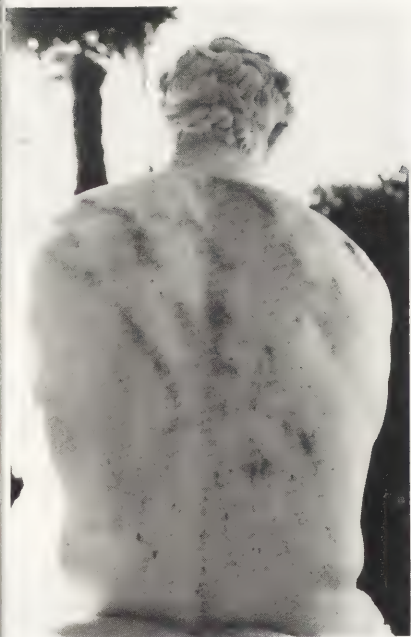
Figure 1. Carrara marble statue at Hearst San Simeon State Historical Monument. Stains have penetrated deep into the stone in crevices left by the dissolution of the more soluble inclusions.

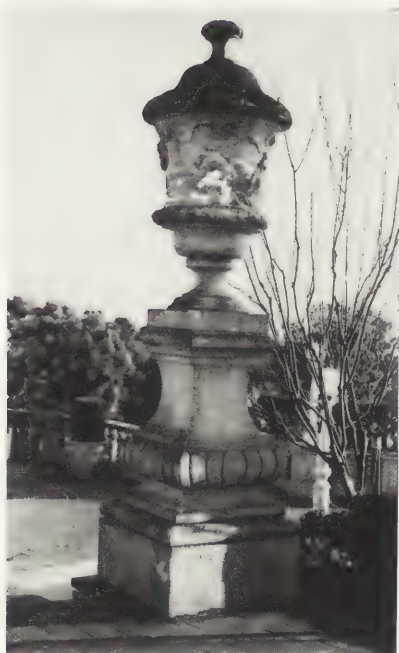
Figure 2. Ornamental limestone urn from the Hearst San Simeon State Historical Monument. The lid is entirely covered with microfloral growth.

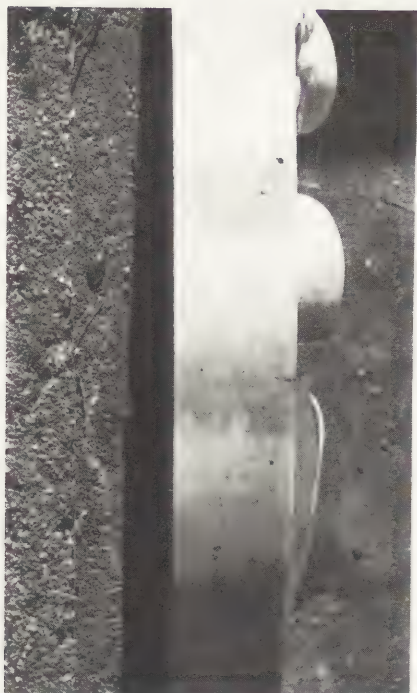
Figure 7. Detail of the top of the relief shown in Figure 4. Four areas were test cleaned with (from top to bottom): calcium hypochlorite, AB 57, hydrogen peroxide, and Chloramine-T.

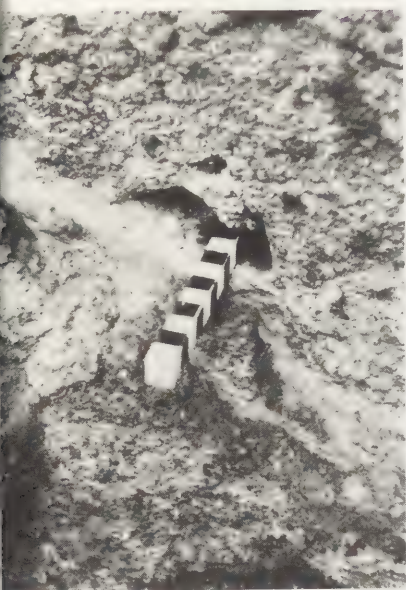
Fig. 3: Detail of a tuff scale consolidated with hydraulic mortar.

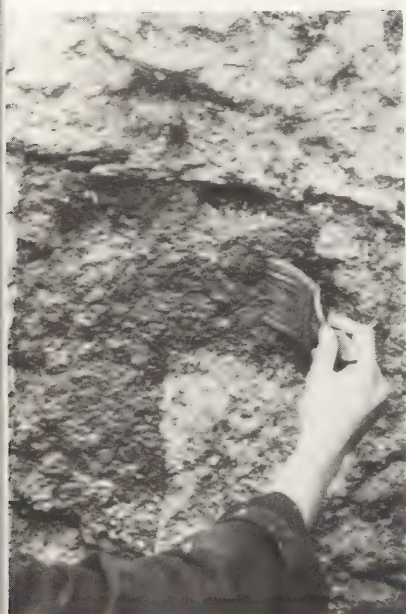
Fig. 4: Application of the lime-wash on a block of tuff.

The solution chosen was to bring the whole tuff wall to a surface porosity similar to that of the plaster, creating a "sacrificial surface" on which the soluble salts carried by the infiltration from behind can crystallize without damaging the stone. A compromise between plaster and tuff was sought: a coat of porous, water-permeable material, a lime-wash (8) (100 cc slaked lime, 500 cc water, 3 cc pigment, natural earth umber), applied onto the surface of the tuff not already covered with plaster (Fig. 4).

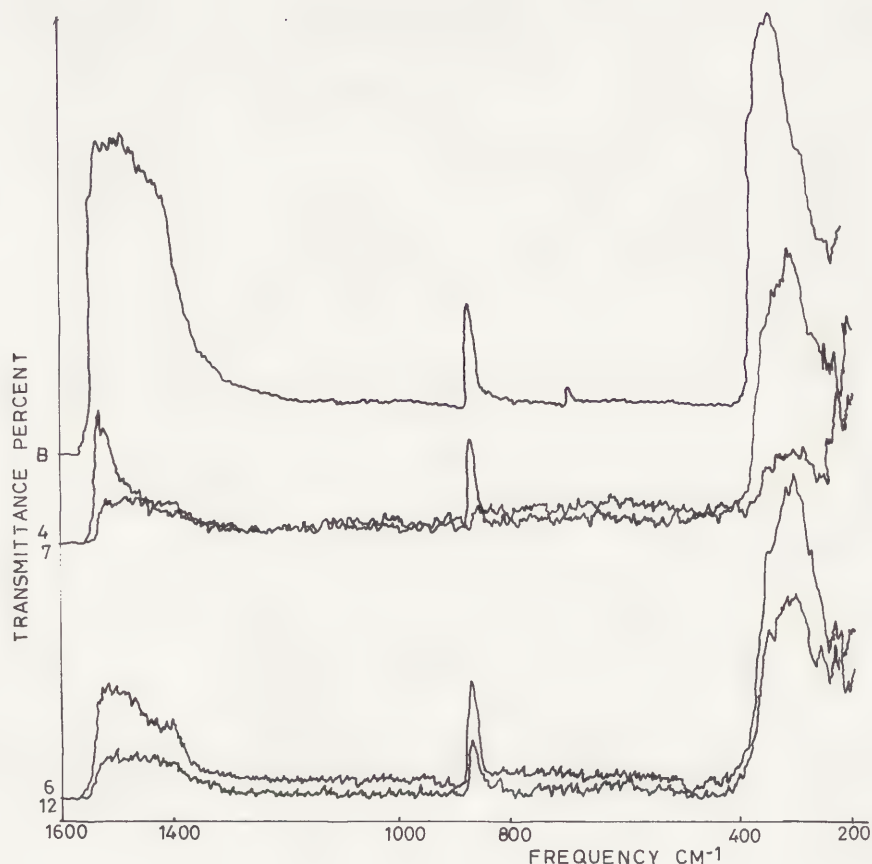
FIG 7 Reflectance infrared spectra of marble samples coated with the inhibitors

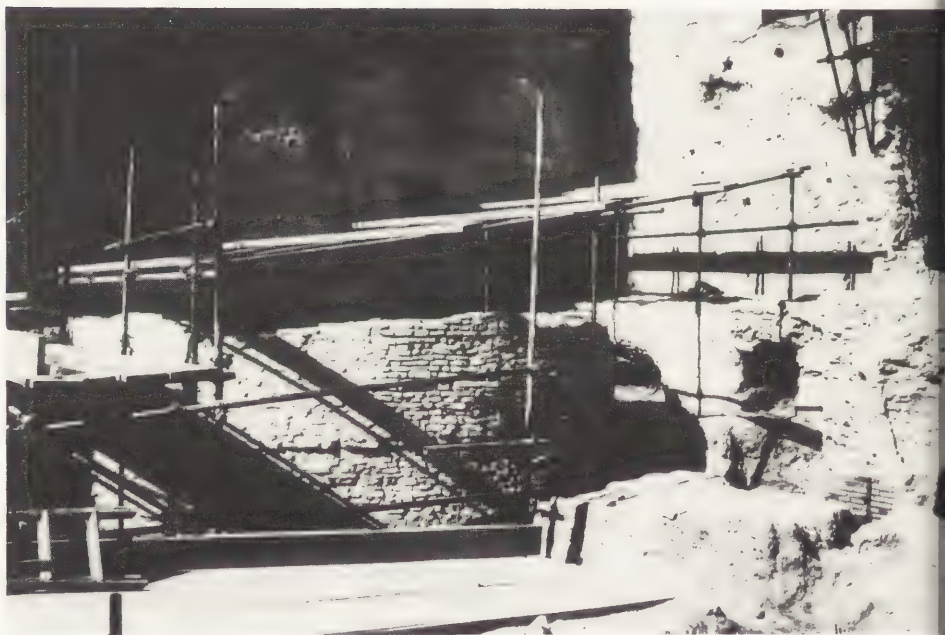
Figure 1. Wall of mudbrick laid in clay. General view showing the temporary shelter of metal tubing, corrugated plastic and bamboo screening. This roof serves to keep off rainwater and to limit insolation, overheating and drying of the clay. The wall is about 4 m high.

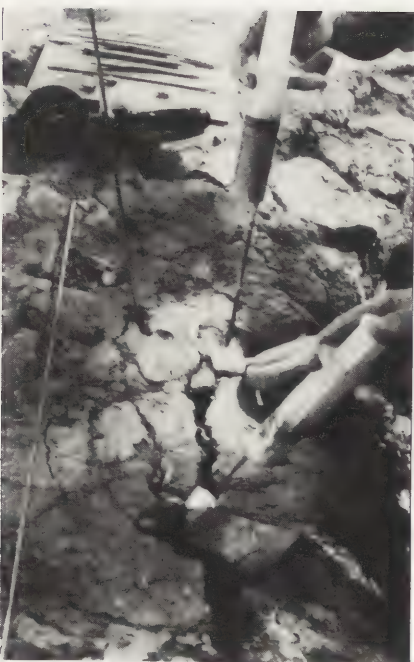
Figure 5. Consolidation with infiltrations of a clay solution combined with 10% hydraulic lime.

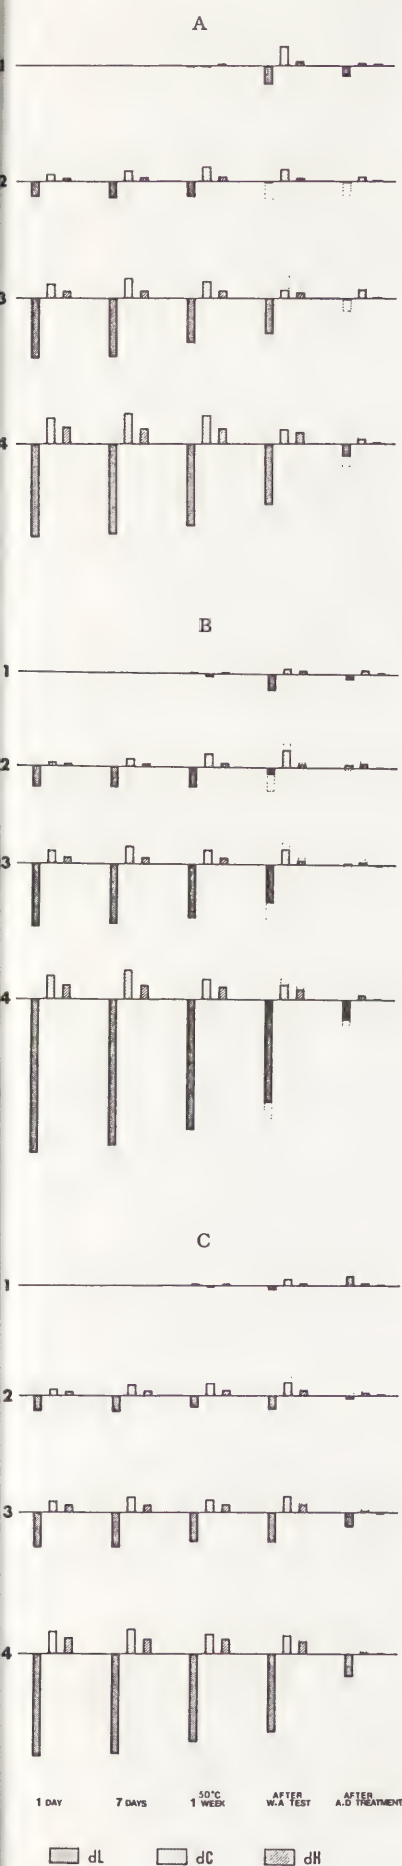
Fig. 5 Difference of value, chroma and hue at each step of the test

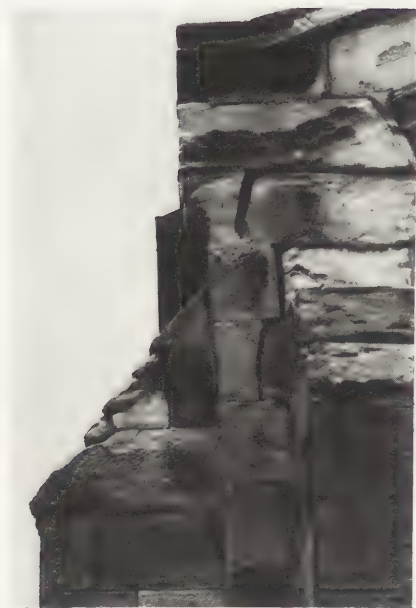
FIG.3. CRACKING AT WALL
JUNCTIONS DUE LATERAL
DISPLACEMENT OF ROOF LOADS

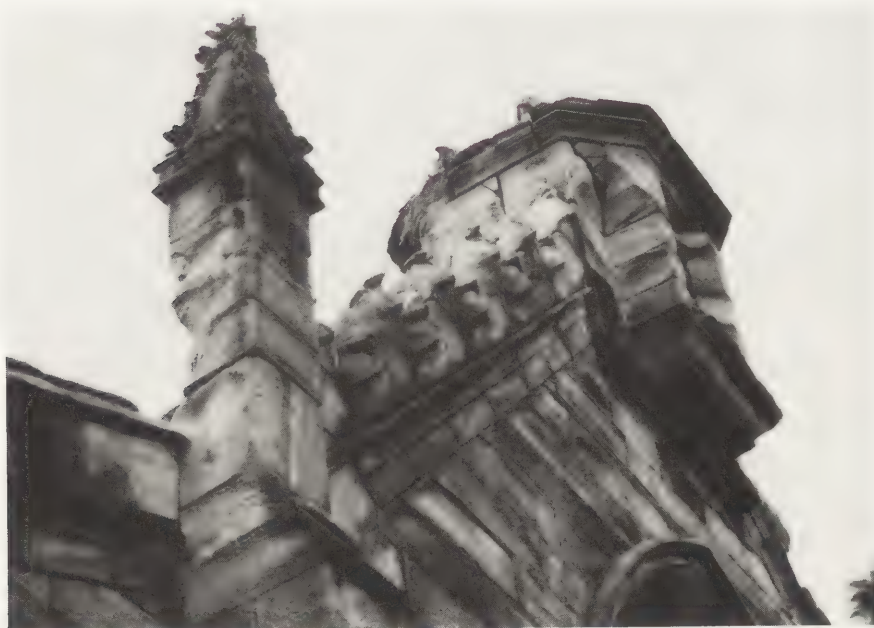
FIG.5. DETAIL OF DECAY TO "WHITE" SANDSTONE ENRICHMENTS

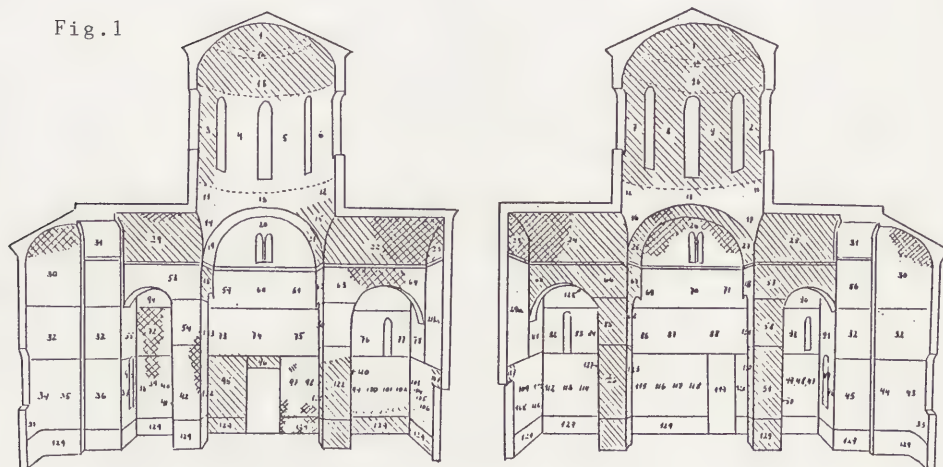
Fig. 1

- original paintings, 14th c.
- ▨ restoration-additions-, 1483-1484; 1, 1a, 1b: 19th-20th c.
- ▩ damaged paintings

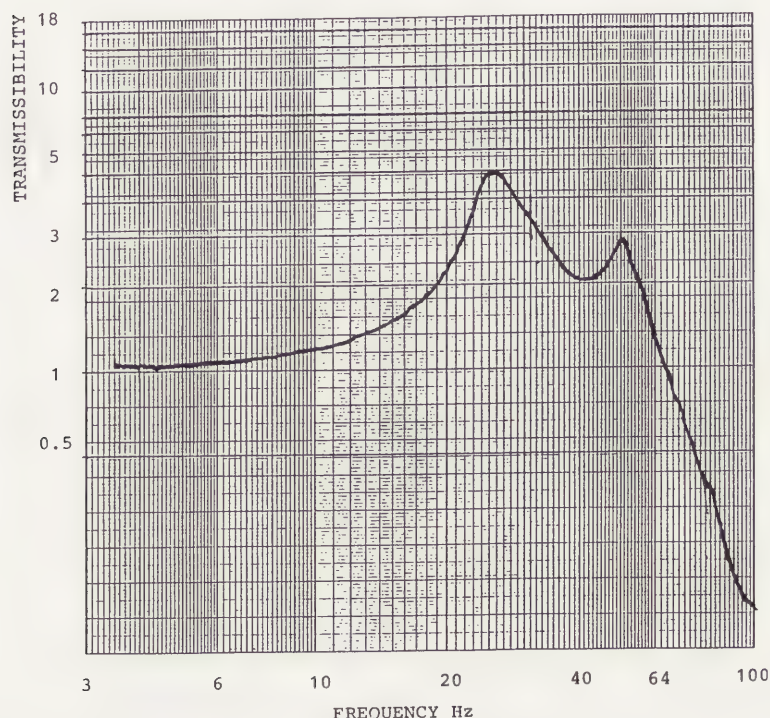
fig a.

By way of illustration, a trace obtained during a frequency sweep is reproduced in fig (a). This shows a peak resonance of five times the vibration table's 'input' occurring at about 25Hz. It is apparent that as the frequency is increased resonance builds to a peak value and then falls away. When unity is reached, at 64Hz, higher frequency vibrations are reduced or 'attenuated'. The excursion in the trace around 50Hz is caused by the packing-case sides resonating.

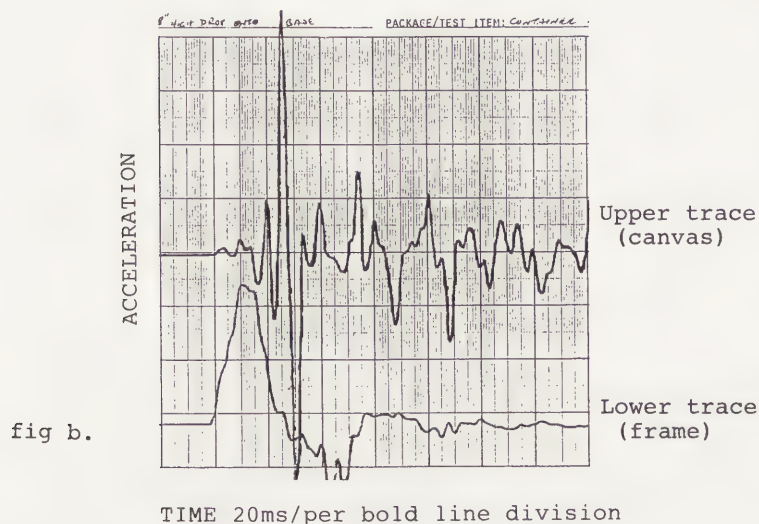
It was possible to store the impact pulse and subsequently to make a trace plotting acceleration in 'g' against time. One example of such a trace is shown in figure b. This was a record of a flat base drop from 457mm (18"). The time base is 20 milliseconds per bold line division, and acceleration is scaled to 20g per bold line division. The lower trace is for the frame, and the upper trace for the canvas.

On impact, the frame was decelerated during 12ms reaching a pk 52.4g, after which it accelerated in the opposite direction (to a peak 24.4g). The canvas, meanwhile, began vibrating but did not develop a high 'g' until some 15ms had passed. One high energy cycle occurred with a peak acceleration of 86.4g. This cycle occurred during about 10ms or 1/100 sec., so its frequency was 100 Hz. A pk to pk displacement occurred of 3.75mm (0.15"). Most other traces revealed that at least four high energy cycles occurred, so the trace in fig. b is slightly unusual. In some drops, the highest pk'g' value was not reached until the third or fourth cycle.

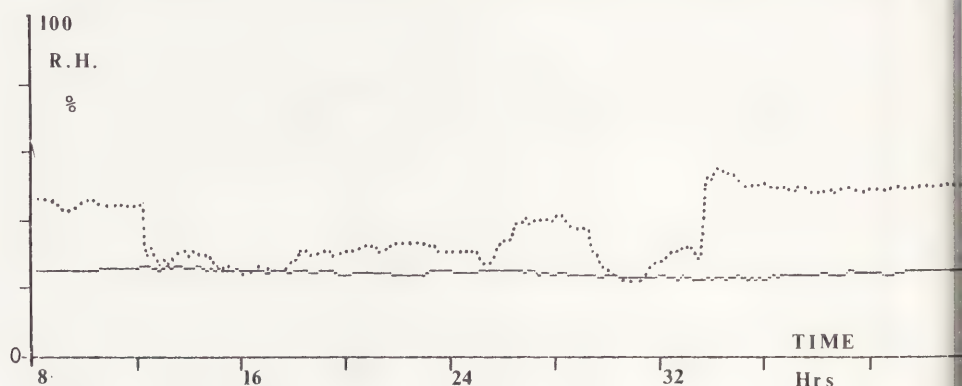
Relative Humidity inside --- the inner polyethylene wrapping and outside the packing case during transit across the Atlantic Ocean by aircraft.

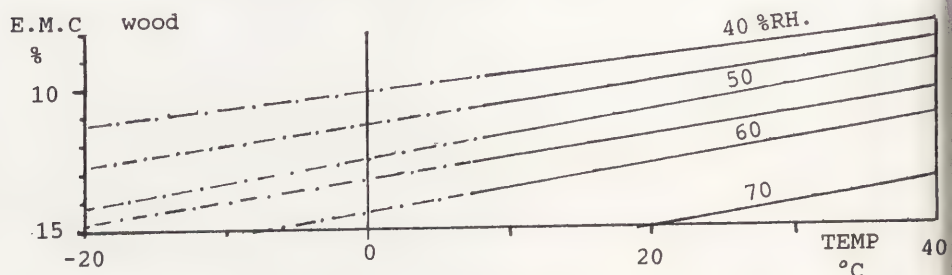
Water vapour isobars
for wood, cotton and
silica gel at different
constant R.H.'s. (Stolow)

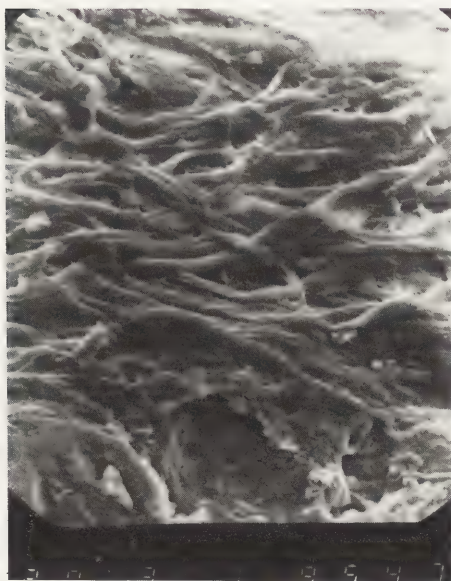
Fig.5.: Photo taken by an electron microscope of the unwritten surface of a 16th c. parchment fragment, 300x

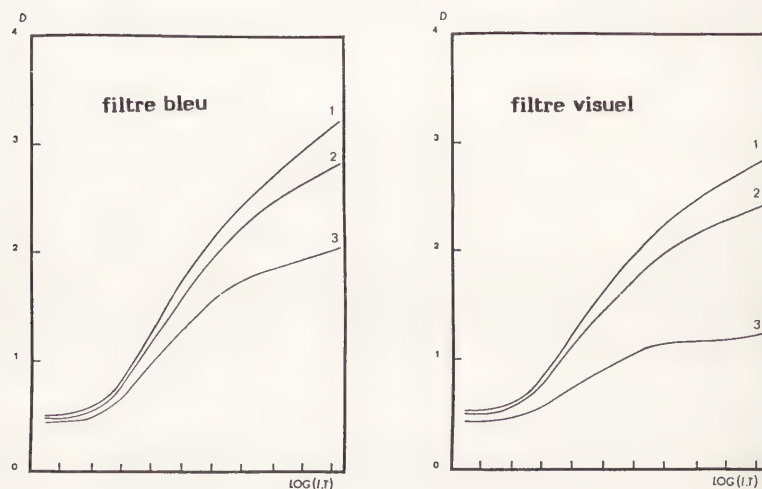
Figure 4 : influence de l'humidité lors du vieillissement des échantillons renforcés

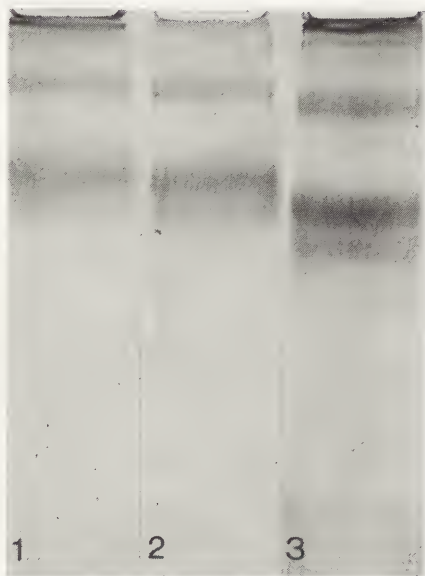
Fig.2: Migration distances of collagen proteins in
(1) untreated,
(2) copper acetate-, and
(3) copper sulfate-treated
samples from calfskin
parchment

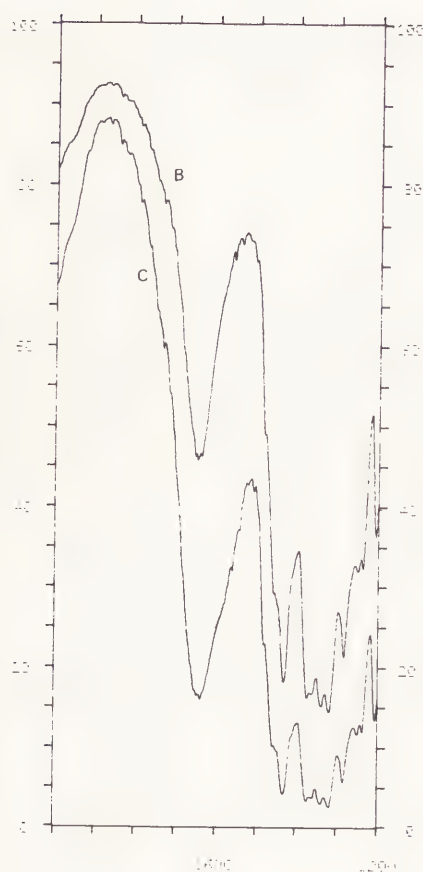
Fig. 2 Spectre B: papier Whatman non traité, vieilli à 90°C et 78% H.R. pendant 60 jours

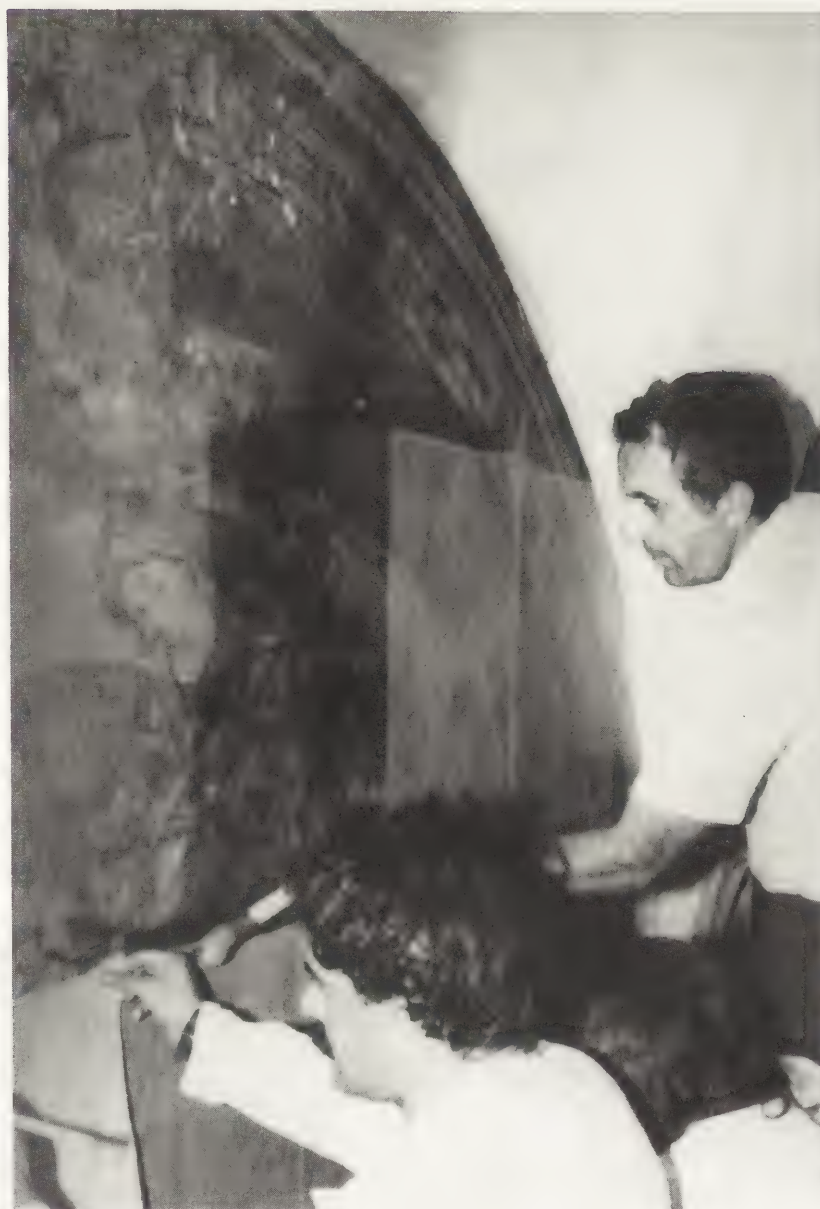
10) phase du "strappo": application des toiles de calicot.

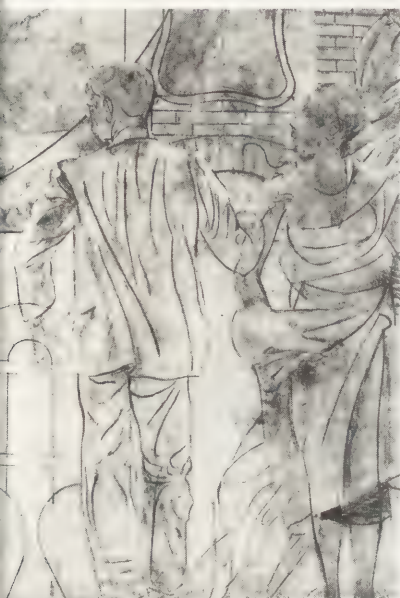
Figure 6
Détail de l'état de dégradation : on remarque la disparition quasi totale des couleurs et seuls les contours du dessin subsistent (comparer cette illustration avec celle de la figure 1, personnage en bas à droite).
(photo M. Stähli)

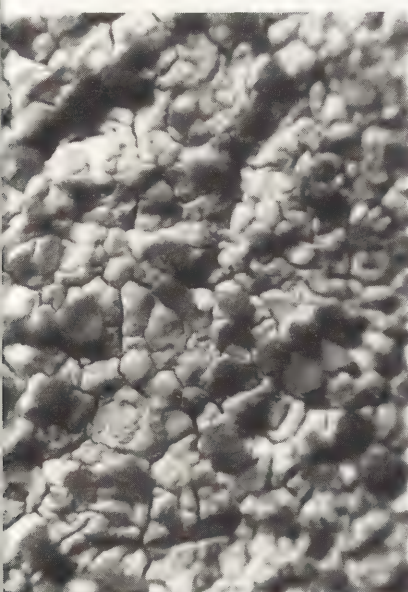
Figure 7
Macrophotographie des microfissures présentes à la surface de l'enduit.
(photo M. Stähli)

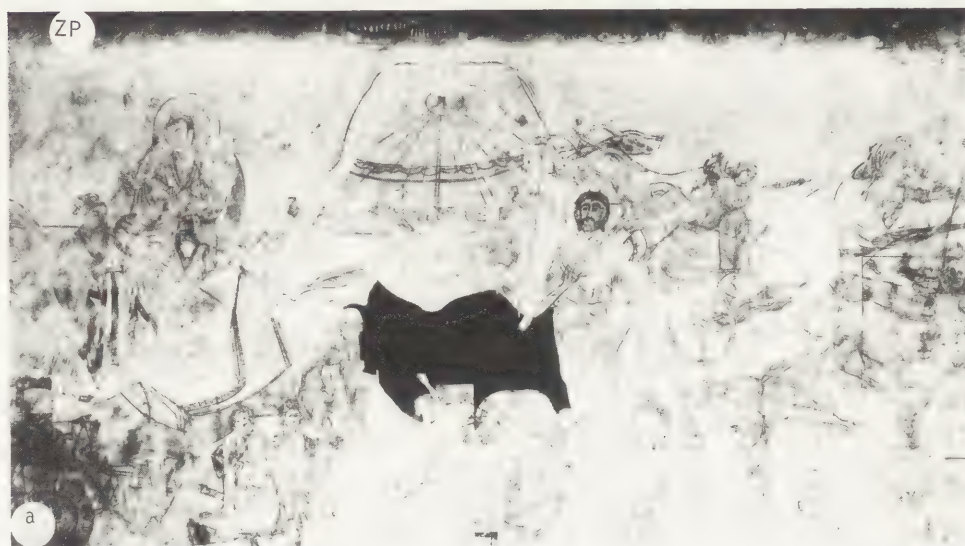
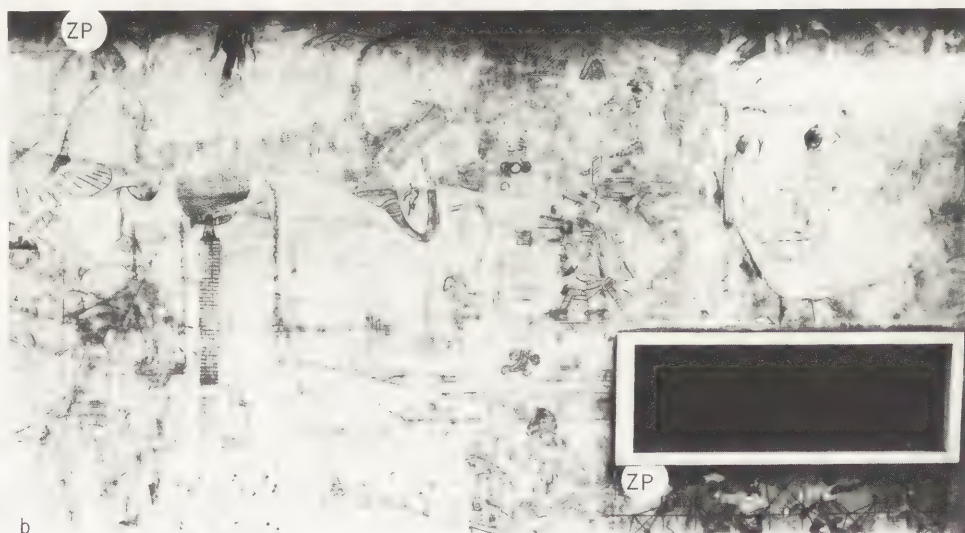
Figure 5 : Etat de la fresque en 1981 : disparition quasi totale de la couleur, à l'exception des zones protégées (ZP) par le petit avant-toit et par la tablette de la fenêtre Ouest.

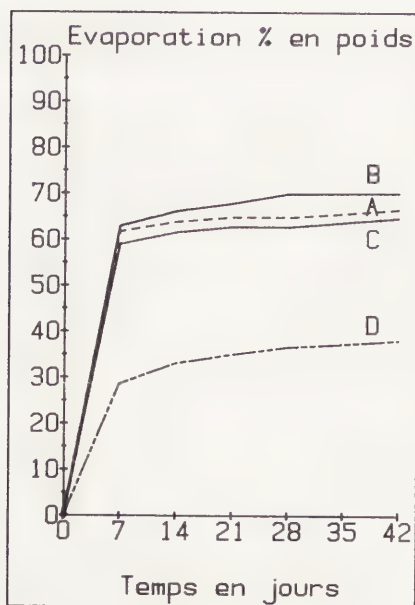
Figure 9
Evaporation des substances
volatiles dans les éprouvettes
de mortier traitées avec les
consolidants.

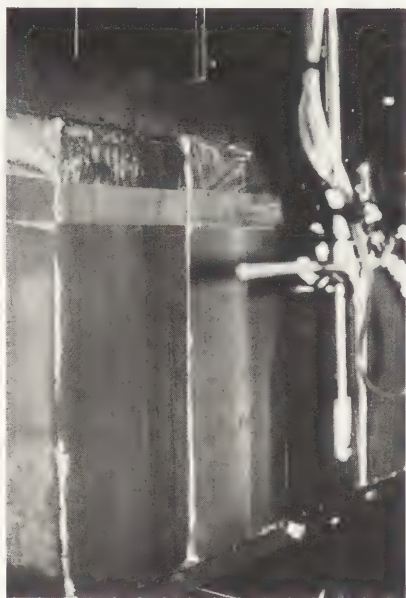
Figure 14
Vue partielle de l'installation de simulation de pluie et des éprouvettes soumises au test.

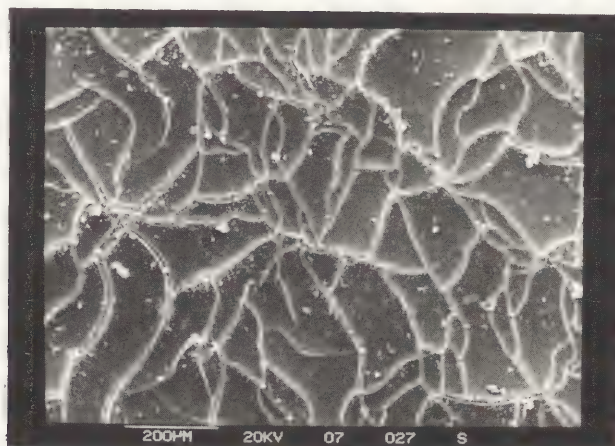
Fig. 9: Istria stone: resin A 48 h aged

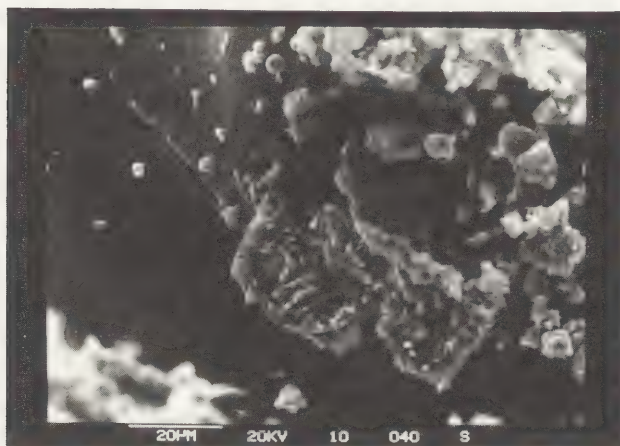
Fig. 10: S. Marco Basilica sample (resin B)

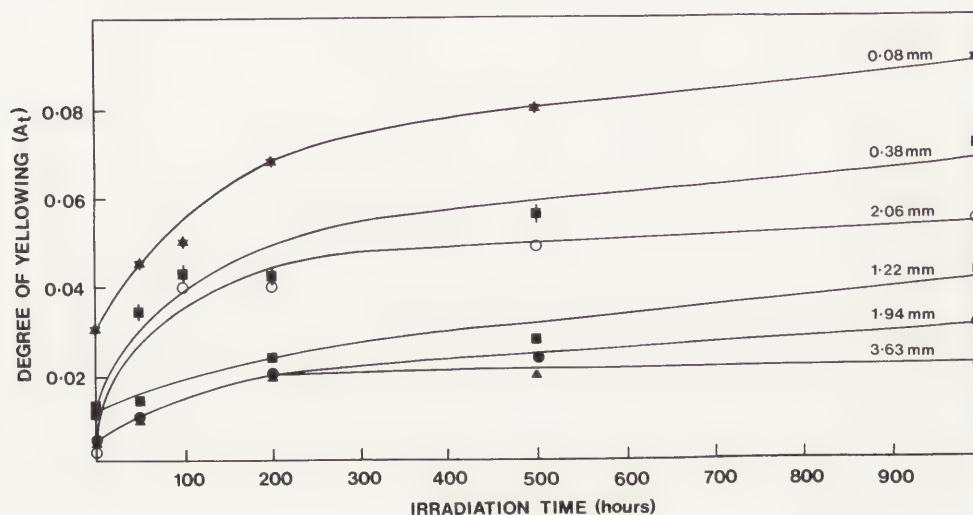
Fig 5: The degree of yellowing of Araldite AY103/HY951 as a result of prolonged aging. (○) represents a sandwich, otherwise casts were solid, of the indicated thickness
